## Machinery Messages

### Case History

# Innovative online monitoring reduces maintenance costs

Electrical and Controls Engineer  
Florida Power Corporation,  
Anclote Plant

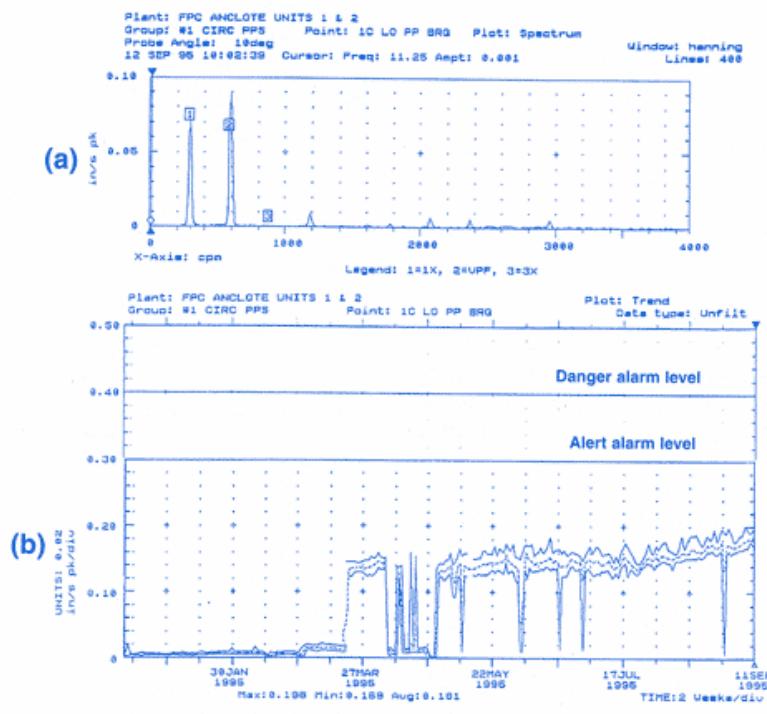
Figure 1 shows Trendmaster 2000 trend and spectrum plots of the Circulating Water Pump taken on September 12, 1995. It indicates a gradual increase in pump vibration amplitudes over a seven month period. The spectrum plot shows a typical 1X rpm for these pumps. The vane pass frequency (2X rpm) is normally approximately one third the magnitude of the 1X rpm. These two plots indicated that the sleeve bearing, which was made of a composite material, was starting to enlarge, allowing the impeller to rotate closer to the pump housing. The next scheduled maintenance outage was in February 1996. It was decided, based on the gradual increase in vibration amplitude, that the pump would operate until the outage. When the pump was inspected in February, severe wear had occurred on the lower bearing, but the pump was otherwise undamaged. Without the Trendmaster 2000 machine information, the pump would not have been inspected until plant operators felt the "rumbling" on the waterfront deck, which would have meant complete bearing failure.

(a) Spectrum plot showing peaks at 290 cpm and 580 cpm.  
(b) Circulating water pump trend plot showing gradual vibration increase.
